# High Temperature Oxidation and Corrosion of Spark Plasma Sintered FeCrAlTiY-10 Mass% MoSi<sub>2</sub> Coating on Low Carbon Steel

**Abstract.** In the present study, we prepared the FeCrAlTiY-10 mass% MoSi<sub>2</sub> coating on low carbon steel using the spark plasma sintering (SPS) technique. Its resistance against oxidation and corrosion was studied in air and atmosphere containing 20 mass% NaCl at 700°C for 8 cycles. The results show that a dense coating layer is composed by FeCr containing Al and MoSi<sub>2</sub> phases. After high temperature oxidation test, a thin protective Al<sub>2</sub>O<sub>3</sub> layer was formed. While mix oxide scales composing of (Cr,Fe)<sub>2</sub>O<sub>3</sub>, Al<sub>2</sub>O<sub>3</sub>, and Fe<sub>3</sub>O<sub>4</sub> were formed after high temperature corrosion test. Although, the affected area after corrosion test was more severe than after oxidation test, the corroded sample somehow had a lower mass gain compared to oxidized sample after 8 cycles exposure. This could be related to the effect of chlorine ions and oxide spallation during cyclic corrosion test.

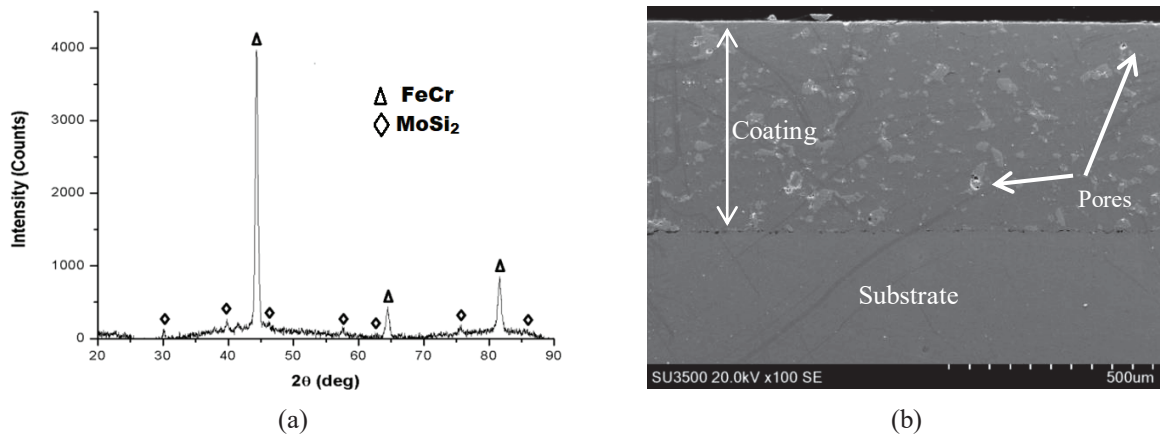
Figure 1 (a) shows the XRD pattern of FeCrAlTiY-10 mass% MoSi<sub>2</sub> coating deposited using Spark Plasma Sintering (SPS) technique on the surface of low carbon steel. The diffraction peaks of FeCrAlTiY-10 mass% MoSi<sub>2</sub> coating are detected as FeCr and MoSi<sub>2</sub> phases. There is no oxide formed due to that the sintering process with SPS is carried out in a vacum condition (< 6 Pa), hindering the oxidation of coating elements. Fig. 1(b) shows cross-sectional microstructure at the coating/substrate interface. It can be seen that a very small fraction of pore can be observed.

**FIGURE 1.** (a) XRD pattern and (b) SE-SEM cross-sectional microstructures of FeCrAlTiY-10 mass% MoSi<sub>2</sub> coating

The cross-sectional microstructures of the coating after high temperature oxidation test are given in Fig 4(b). Visually, no significance different is found in the coating after and before oxidation test (Fig. 1(b)). However, EDX elemental maps of oxidized sample as shown in Fig. 5 clearly show the fine distribution of Al and O in the external layer. This result is in good agreement with the result of XRD analysis, as shown in Fig. 4(a) which is confirming that the fine distribution of Al and O must be Al<sub>2</sub>O<sub>3</sub> layer. This thin oxide layer can acts as protective barrier for oxygen inward diffusion.

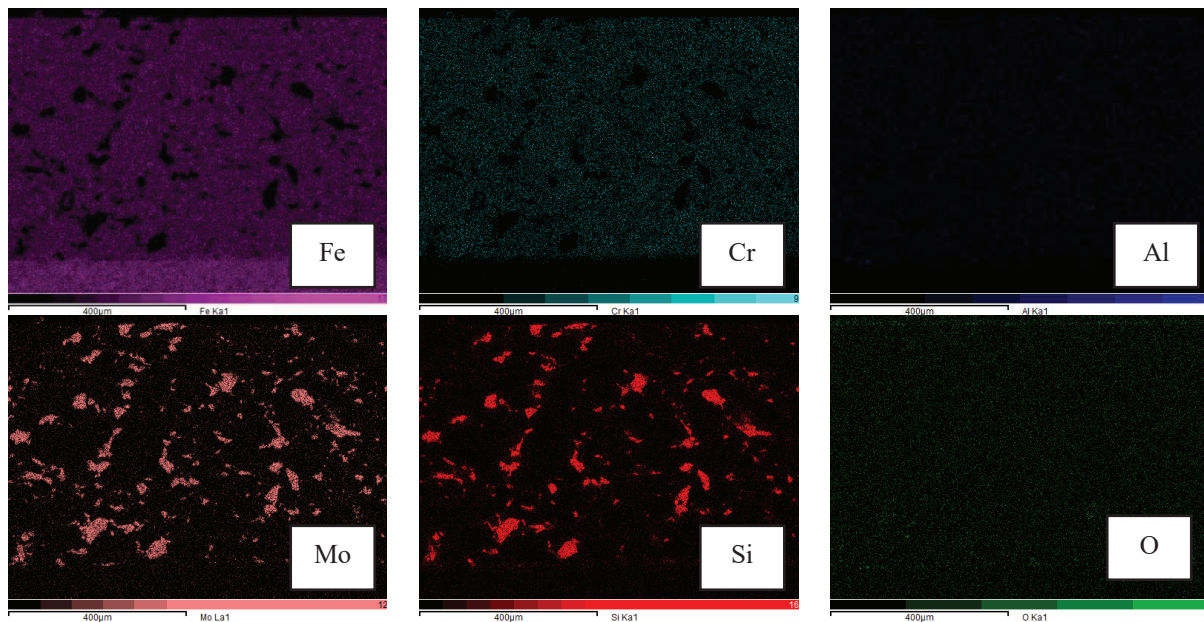
Figure 2 shows the EDX element mapping of FeCrAlTiY-MoSi<sub>2</sub> coating after sintering at 900°C. The results show that the dominant coating elements are Fe (magenta color intensity), Cr (cyan color intensity), Mo (pink color intensity) and Si (red color intensity). Although the coating contains some amount of Al element, the Al distribution in the coating is not clearly observed. This could be due to fact that it is finely distributed in the coating layer. Moreover, it is important to note that no oxygen distribution is found in Fig. 2. This indicates that the oxidation during coating preparation does not occur. The detection of Fe, Cr, Mo, Si distribution in the coating supports the XRD analysis results which show that the coating is composed mainly of FeCr and MoSi<sub>2</sub> phases, as shown in Fig. 1(a).

**FIGURE 2.** EDX elemental mapping of FeCrAlTiY-10 mass% MoSi<sub>2</sub> coating

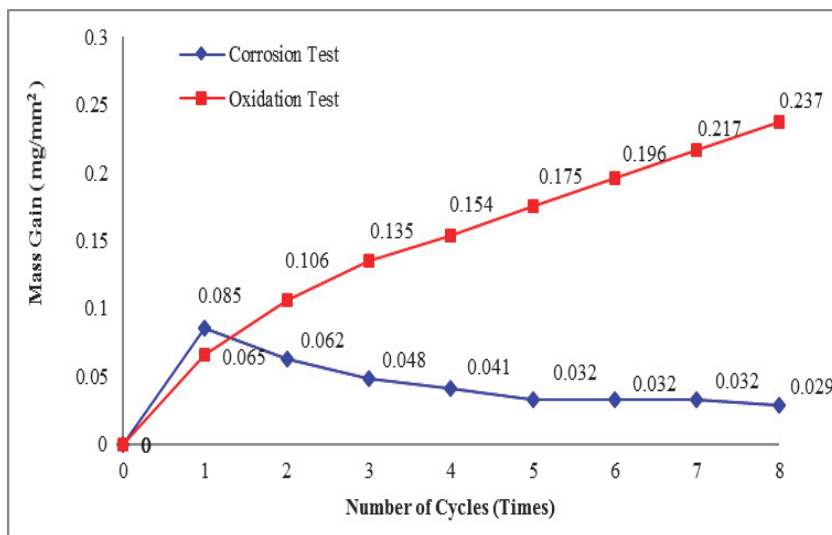
Figure 3 shows the mass gain curve per unit area of FeCrAlTiY coating with 10 mass% MoSi<sub>2</sub> after oxidation and corrosion test at 700°C for 8 cycles. In the initial stage, oxidation at high temperatures cause a rapid surface reaction which cause an increase in the rate of ion migration, resulting in the oxide layer formation [13] and an increase in mass gain of the sample. As shown in Fig. 3, the corroded sample has a lower mass gain compared to oxidized sample at 700°C for 8 cycles which is 0.029 mg/mm<sup>2</sup> and 0.237 mg/mm<sup>2</sup>, respectively. It is interesting to note that for corroded sample, the mass gain increases in the first cycle of the test then decreases with the increase of cyclic corrosion time. This is probably due to the influence of chloride ions. Previous study reported that in the atmospheric condition, chloride ions seem to only work during the corrosion initiation and failed to penetrate through the thick rust layer at later stages, so that corrosion rates increased initially and then

declined with the exposure time in atmosphere [14]. Another reason is that some amount of corrosion products may spall out from the sample surface.

**FIGURE 3.** Mass gain curves of FeCrAlTiY coatings with 10 mass% MoSi<sub>2</sub> after oxidation and corrosion test at 700°C for 8 cycles

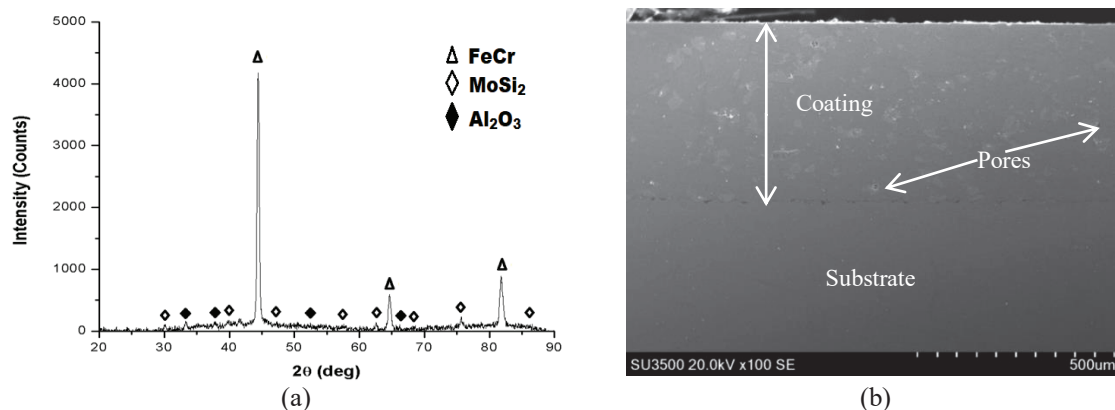
Figure 4(a) shows the results of XRD analysis of FeCrAlTiY-10 mass% MoSi<sub>2</sub> coating after oxidation test at 700°C for 8 cycles. The results show that 3 phases namely FeCr, MoSi<sub>2</sub> and Al<sub>2</sub>O<sub>3</sub> are confirmed from the sample reflection, suggesting that the oxidation product of this coating is mainly an Al<sub>2</sub>O<sub>3</sub>.

**FIGURE 4.** (a) XRD pattern and (b) SE-SEM cross-sectional microstructures of FeCrAlTiY-10 mass% MoSi<sub>2</sub> coating after oxidation test at 700°C for 8 cycles

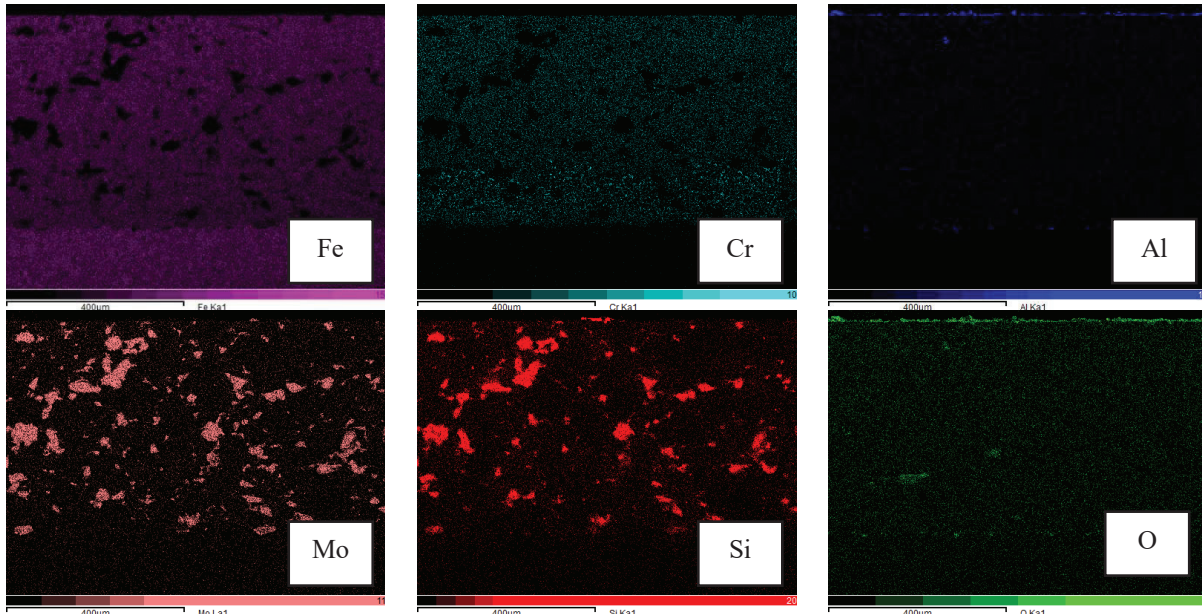
**FIGURE 5.** EDX elemental mapping of FeCrAlTiY-10 mass% MoSi<sub>2</sub> coating after oxidation test at 700°C for 8 cycles

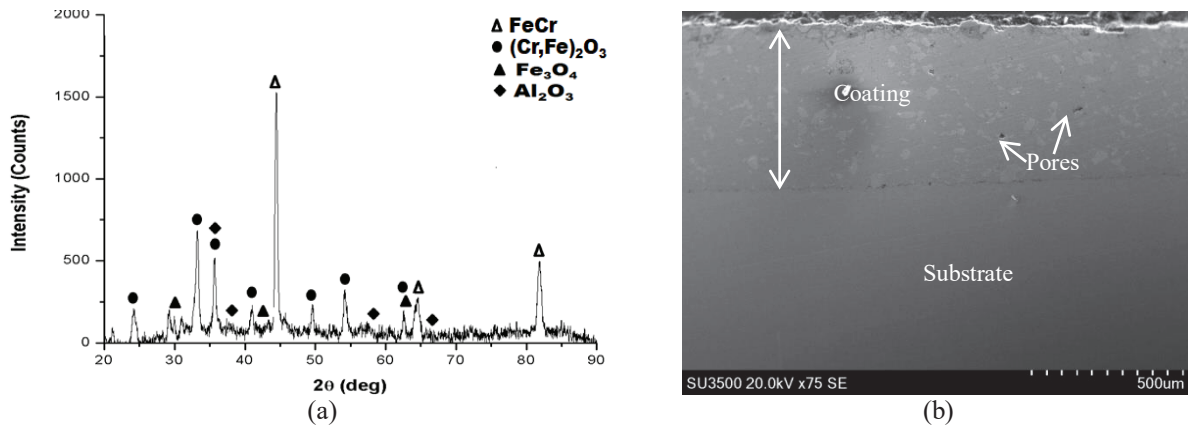
Figures 6 (a) and (b) show the XRD pattern and typical SE-SEM cross-sectional microstructure of FeCrAlTiY-MoSi<sub>2</sub> coating on low carbon steel after corrosion test in air at 700°C for 8 cycles, respectively. As shown in Fig. 6(a), the peaks reflection after high temperature corrosion test corresponds to FeCr, (Cr,Fe)<sub>2</sub>O<sub>3</sub>, Al<sub>2</sub>O<sub>3</sub>, and Fe<sub>3</sub>O<sub>4</sub>.

**FIGURE 6.** (a) XRD pattern and (b) SE-SEM cross-sectional microstructures of FeCrAlTiY-10 mass% MoSi<sub>2</sub> coating after corrosion test at 700°C for 8 cycles

Figure 7 shows the result of EDX element mapping of FeCrAlTiY-10 mass% MoSi<sub>2</sub> coating after corrosion test. The magenta, cyan, pink, red, blue and green color intensities correspond to Fe, Cr, Mo, Si, Al and O distribution, respectively. The EDX elemental maps clearly indicate the distribution of Fe, Cr, Al and O on the coating surface. This results supports the XRD analysis which determine the corrosion products composing of (Cr,Fe)<sub>2</sub>O<sub>3</sub>, Fe<sub>3</sub>O<sub>4</sub> and Al<sub>2</sub>O<sub>3</sub> as shown in Fig. 6(a).

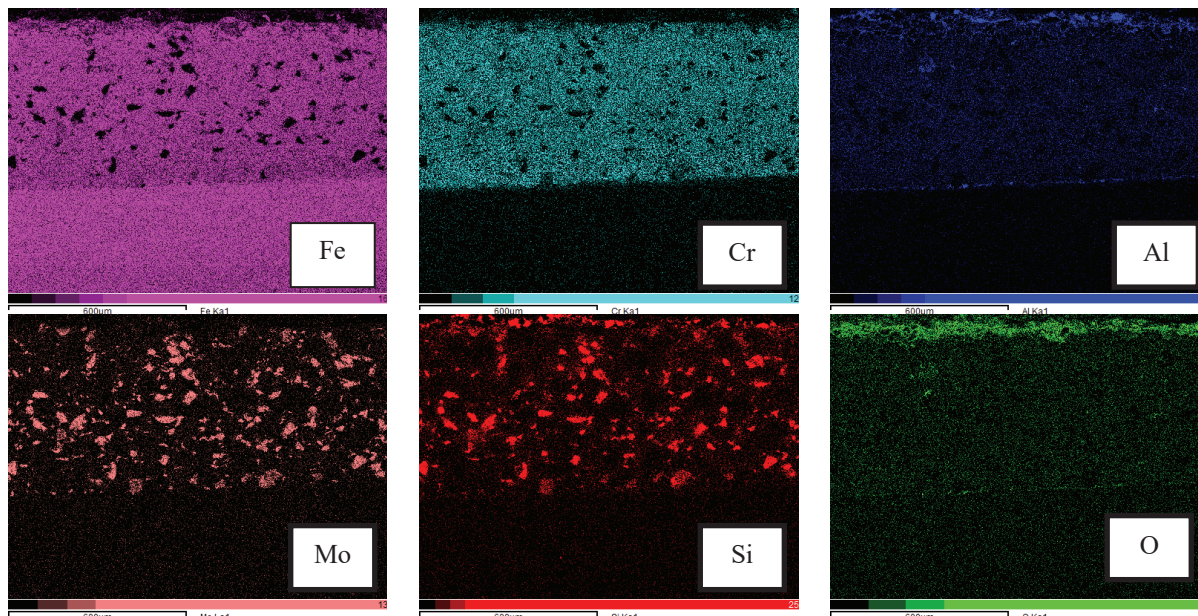
**FIGURE 7.** EDX elemental mapping of FeCrAlTiY-10 mass% MoSi<sub>2</sub> coating after corrosion test at 700°C for 8 cycles
